1. Project Name: Laupahoe Navigation Improvements
2. Date of Inspection: May 6, 2005
3. Inspection Personnel:

# O & M INSPECTION REPORT FOR NAVIGATION PROJECTS

Honolulu Engineer District

## LAUPAHOEHOE HARBOR, HAWAII, HAWAII

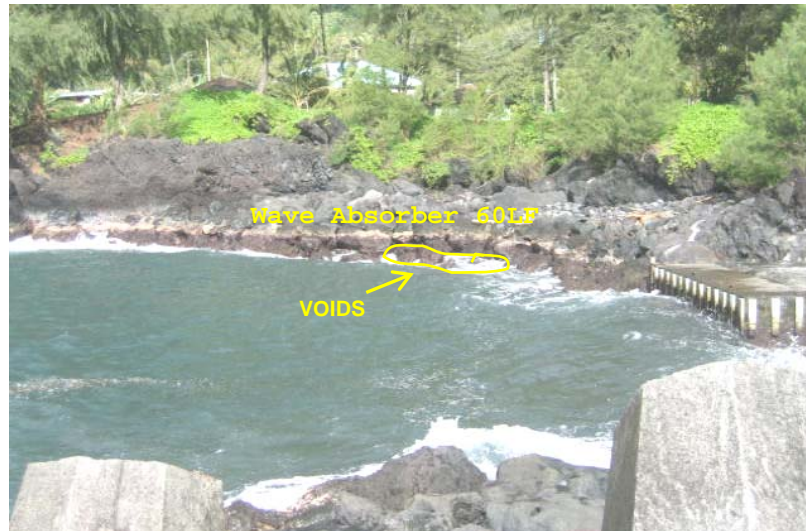
- a. Sta. 0+02 to Sta. 0+10, Missing armor stones at the waterline see voids.

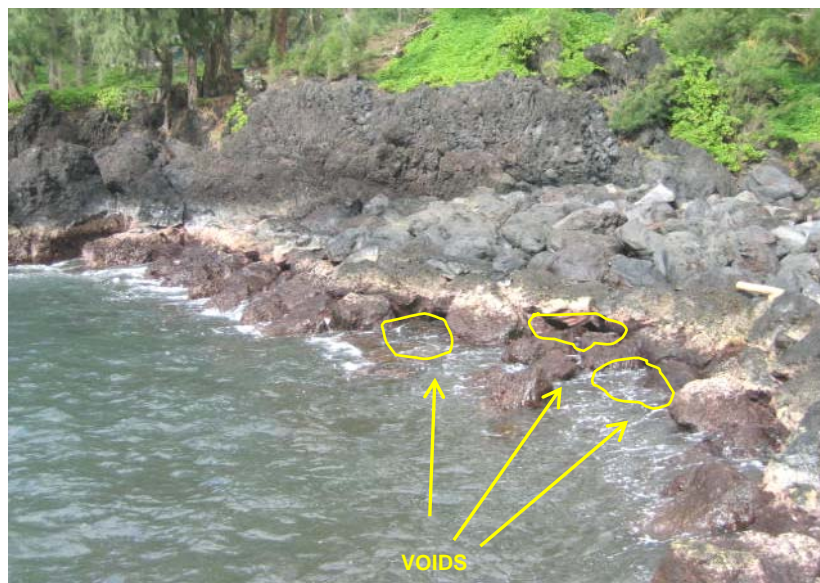
- b. Same as Above, no change since last inspection. Some stones at the waterline are missing and voids are present. Monitor.

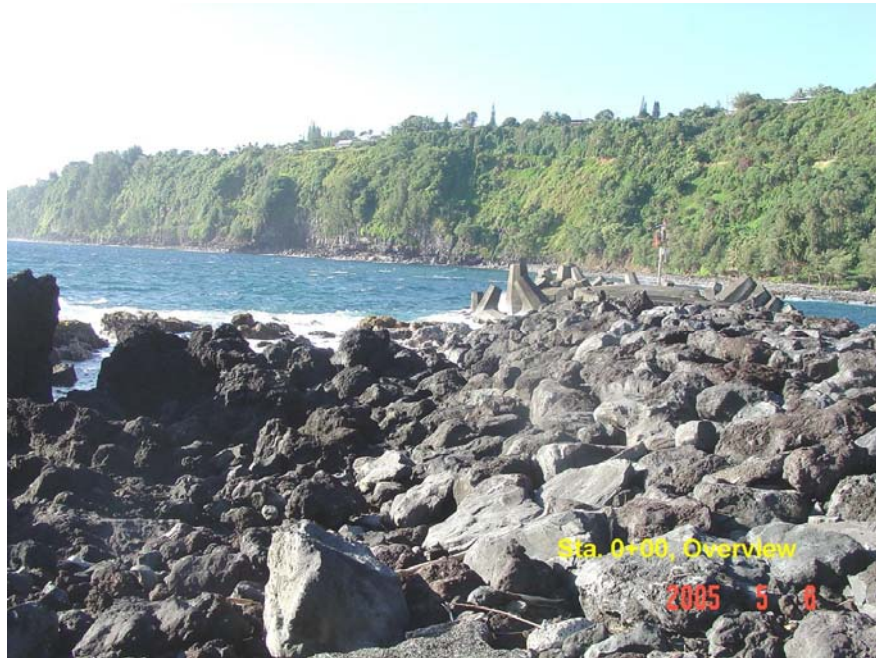
a. Sta. 0+00, Oceanside (OS), Overview of breakwater.

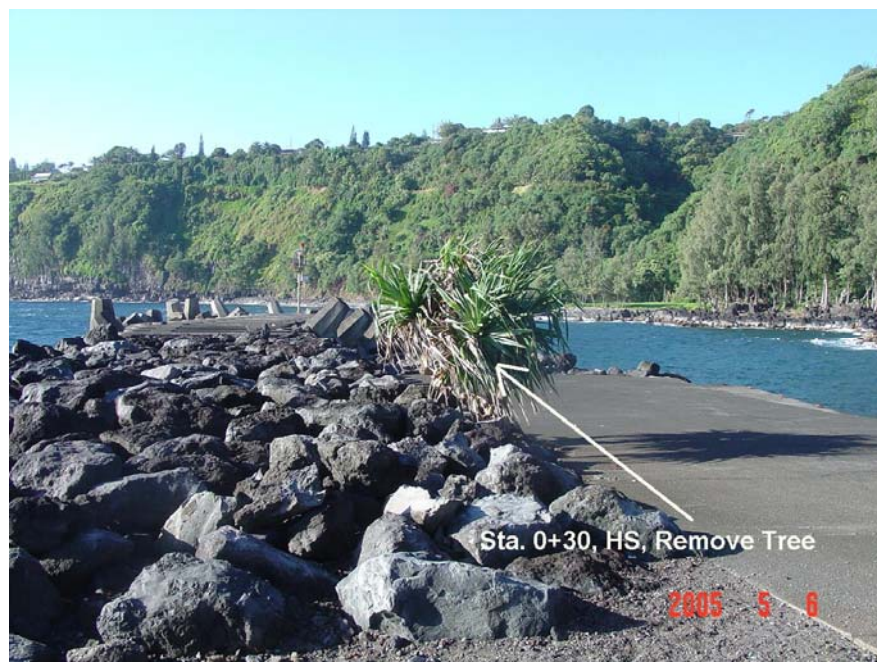
b. Sta. 0+30, HS, Remove tree from armor stones.

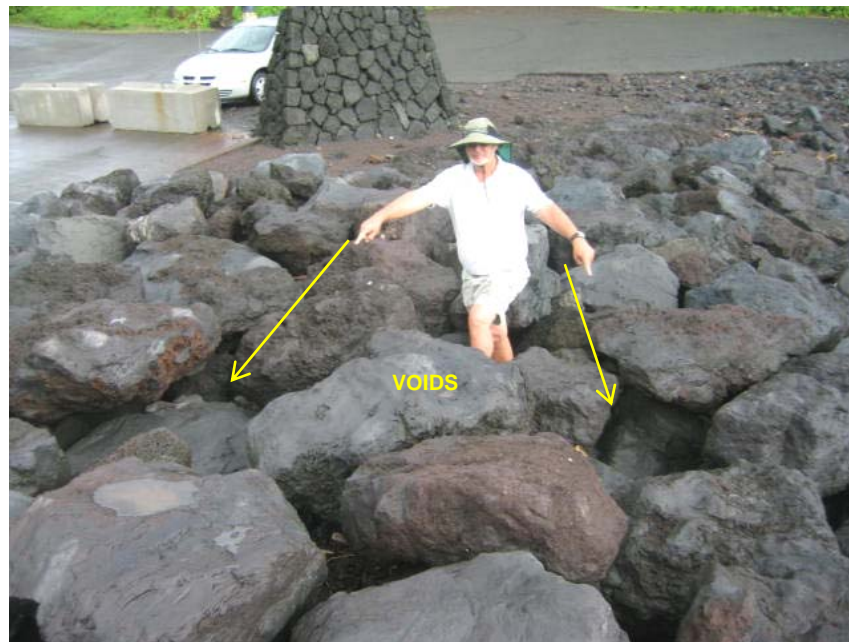
c. Sta. 0+25, 0+26, and 0+28; Voids and missing armor stones.

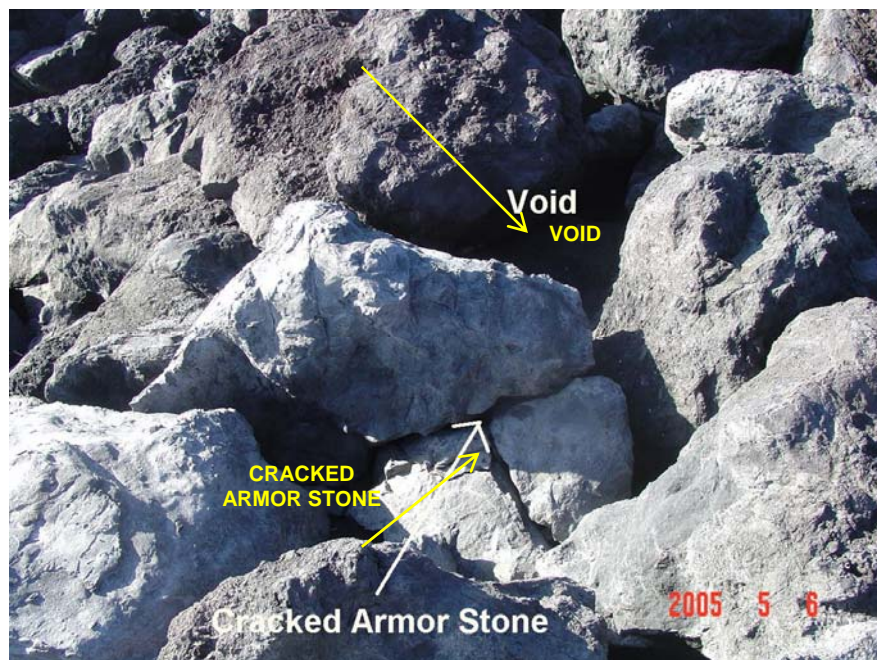
d. Sta. 0+40, Void and cracked armor stone.

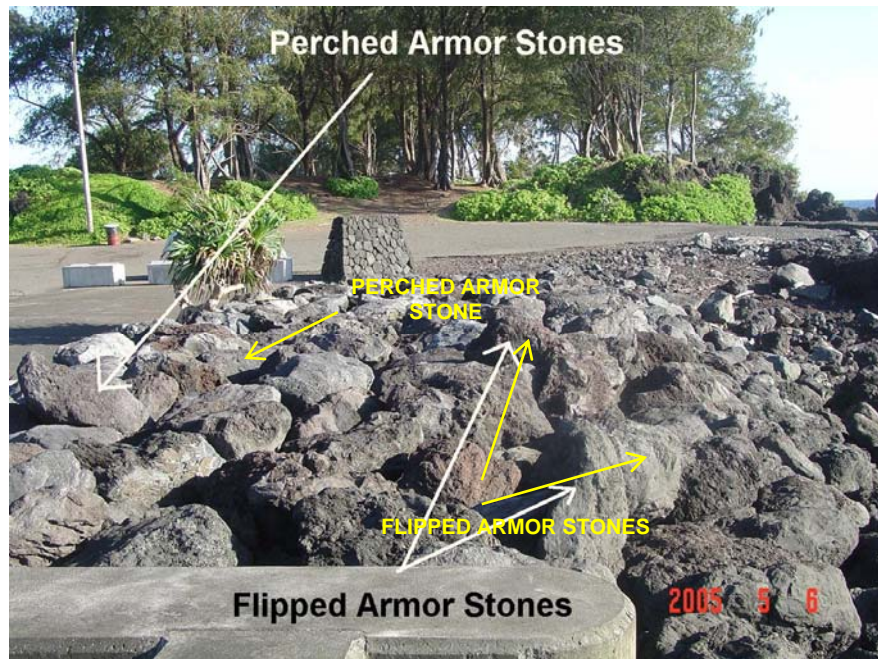
e. Sta. 0+70, HS, 1 ea. Perched armor stone.

f. Sta. 0+75, OS, 1 Flipped armor stone, 3 new flipped stones in this area since last inspection.

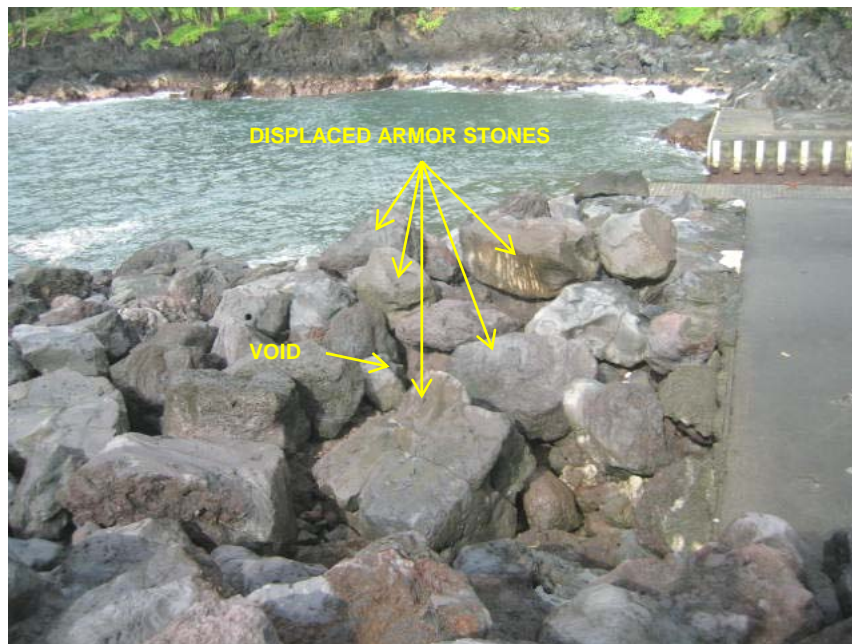
g. Sta. 0+77, HS, Dislodged armor stones, void present.  
5'L x 20'W x 5'D void from dislodged armor stones; several perched stones located adjacent to void.

The Breakwater and wave absorber function as designed, however it appears additional material has washed out from under the rib cap cells and should be closely monitored. The void at Sta. 0+77, HS, needs to be monitored, however suggest repairs be planned for the near future as the dislodged armor stones may impact the turning basin. Overall the project is in MARGINAL condition.

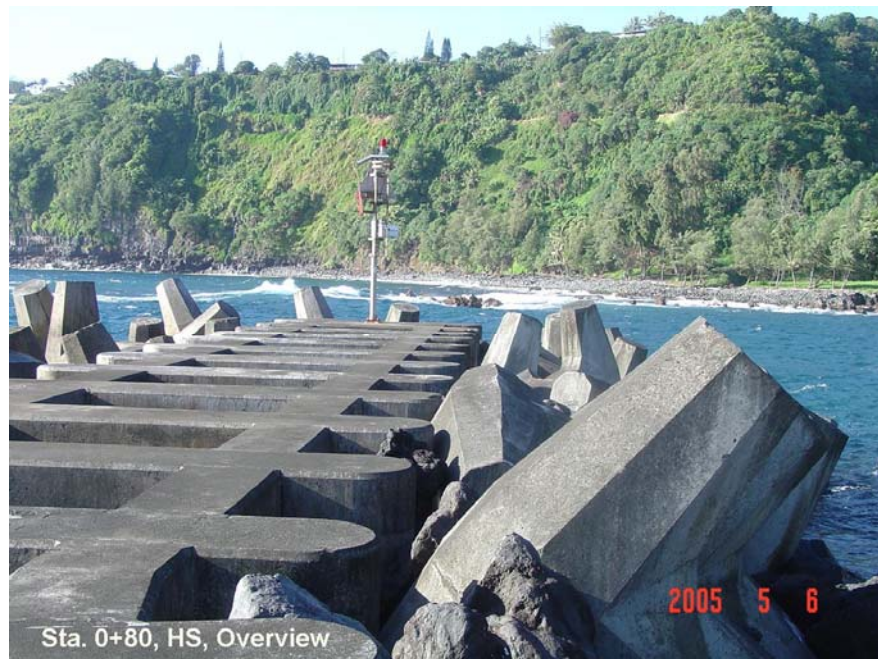
h. Sta. 0+80, HS, Overview of Ribcap / Dolos. Sta. 0+80 to 1+25 (first 6 ribs), HS, 500 pound stones lodged between ribs and dispersed among dolos.

There has been a loss of underlayer material in the cells of the rib cap between the ribs and beams. The typical section depicts two layers of 5 to 7 ton stone directly below the concrete cap and 1 to 3 ton stone underneath. Apparently, the specified stones were replaced with greatly undersized stone during construction. The undersized stone is slowly being washed away, creating a more porous structure that allows more energy into the harbor, and could ultimately threaten the stability of the breakwater.

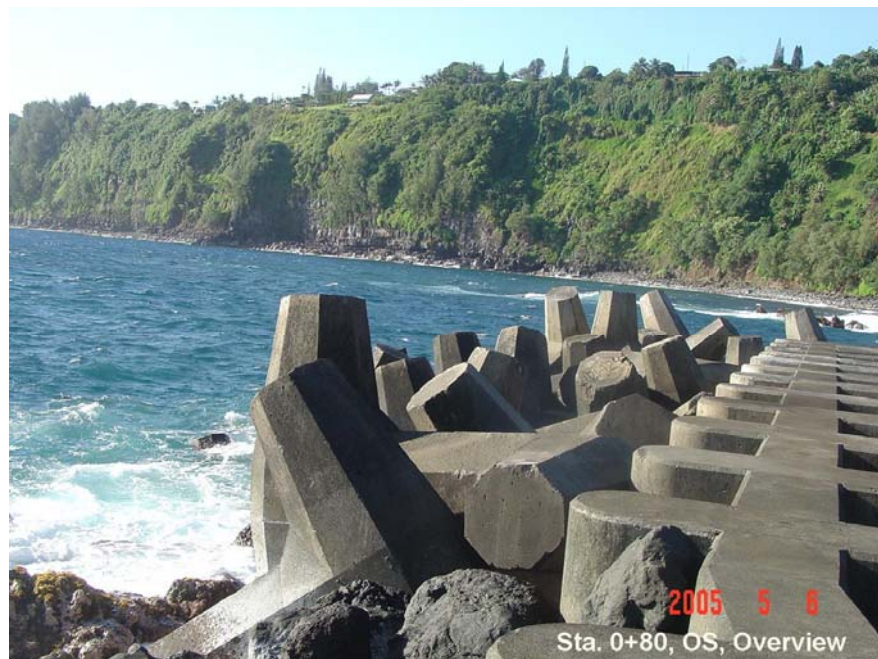
i. Sta. 0+80, OS, Overview of Ribcap / Dolos.

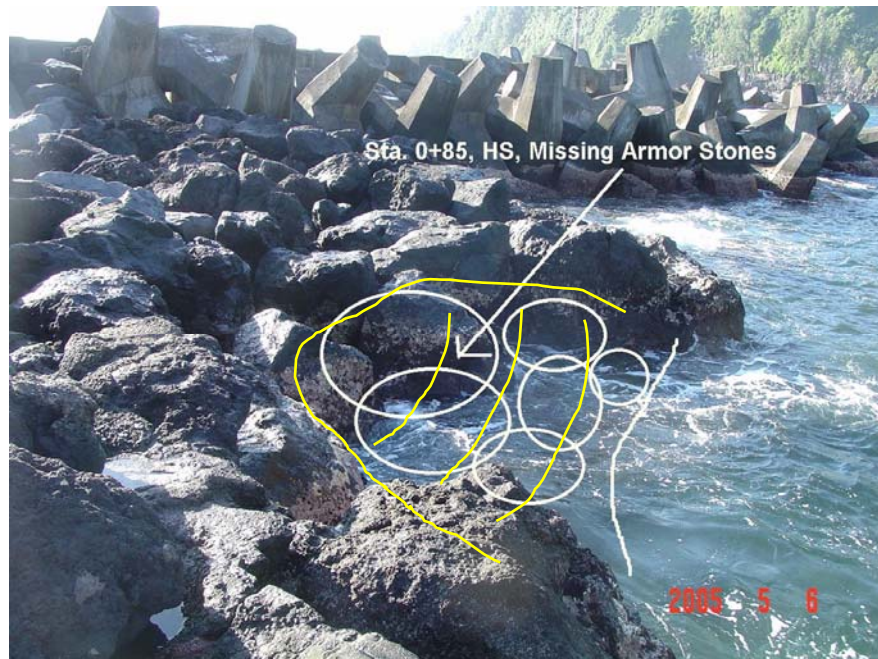
j. Sta. 0+85, HS, missing armor stones adjacent the boat ramp.

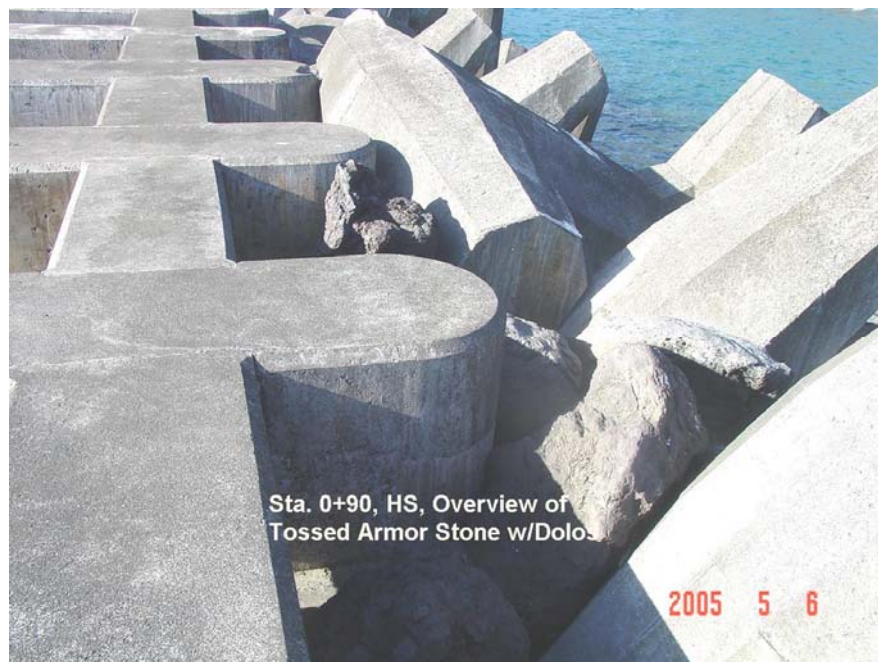
k. Sta. 0+90, HS, Small rocks washed up on dolos (Reference photo).

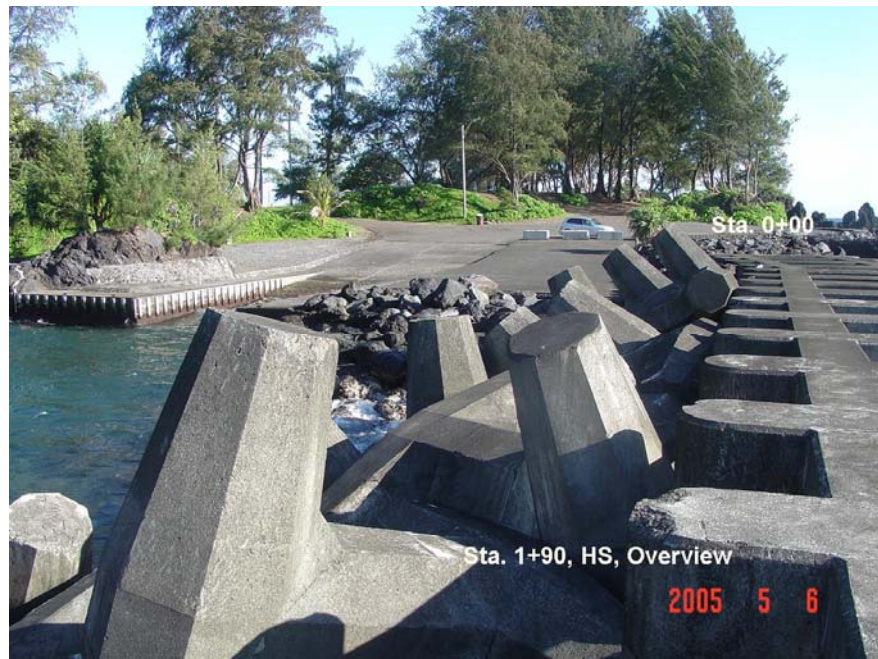
1. Sta. 1+90, HS, Overview.

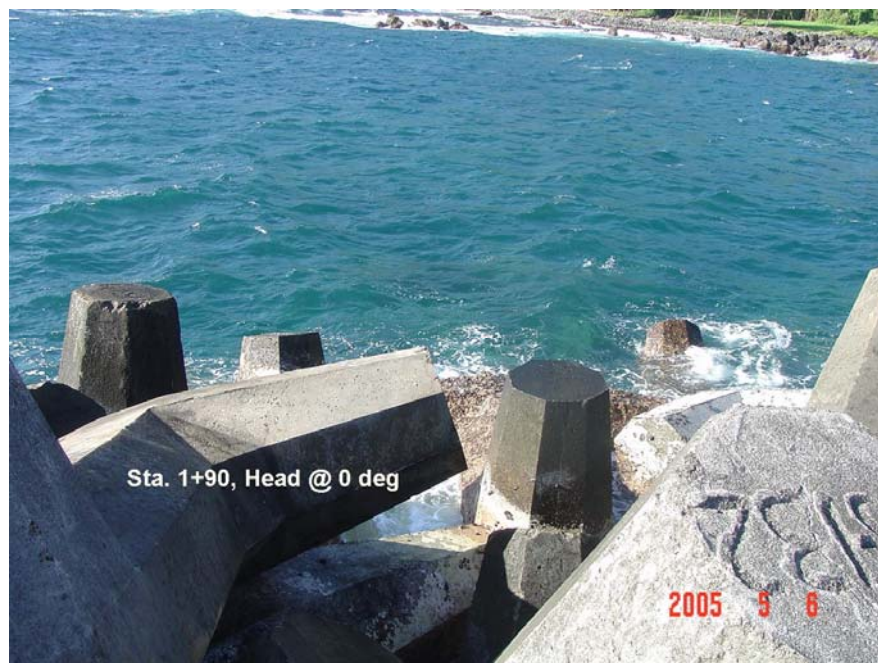
m. Sta. 1+90, Head.

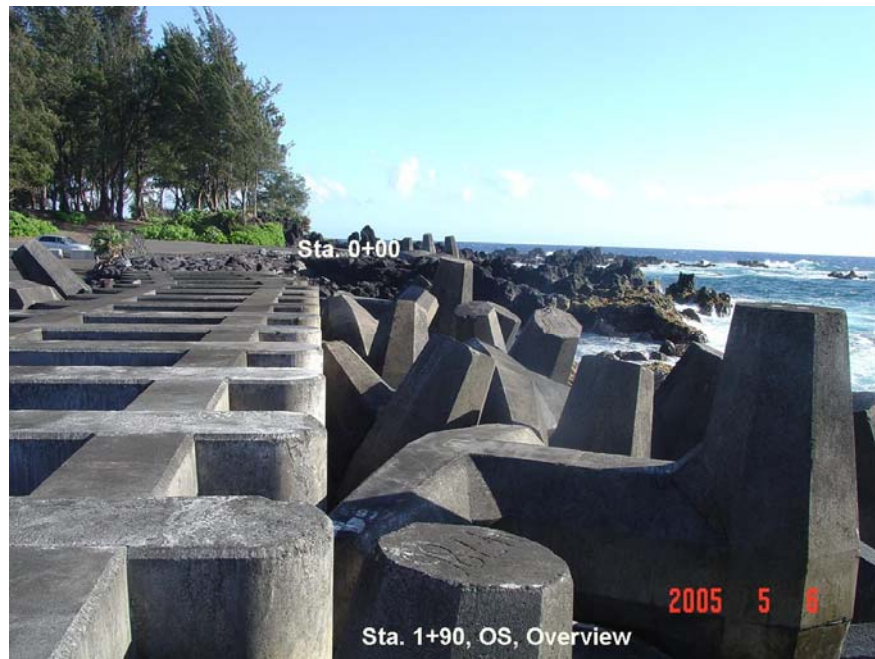
n. Sta. 1+90, OS, Overview.

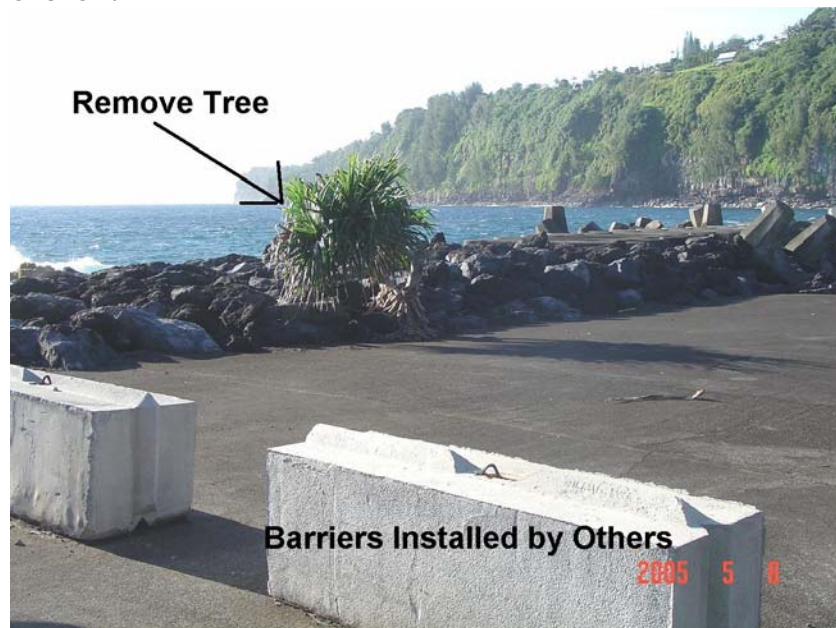
a. Department of Parks and Recreation has placed barriers in front of the concrete slab.

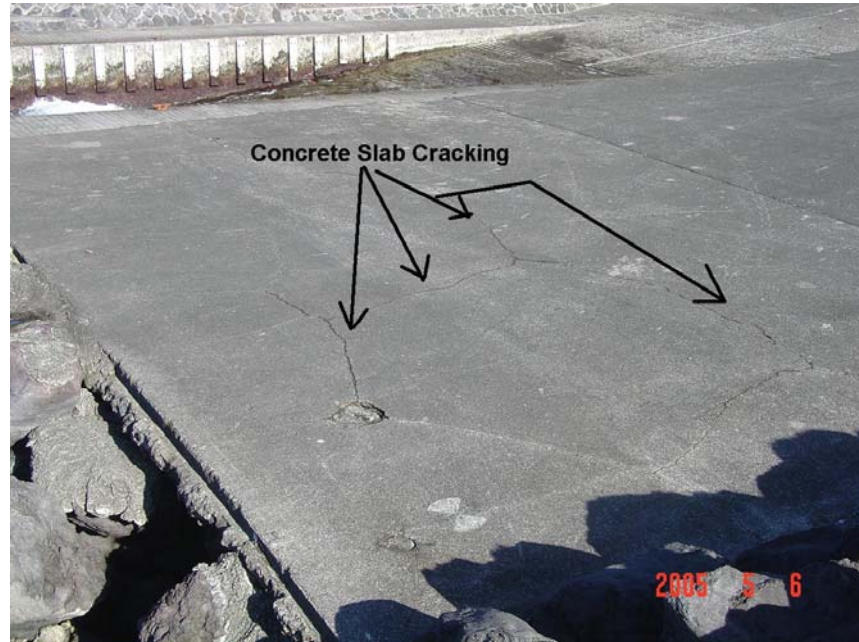
b. Concrete slab adjacent to boat ramp is undermined and cracking due to voids below.

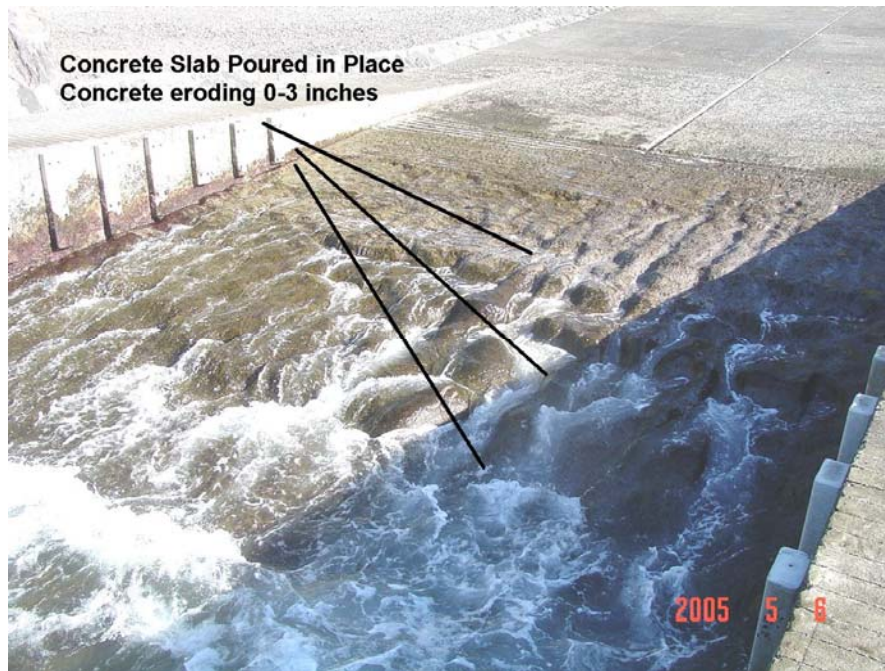
c. Boat Ramp Concrete erosion up to 3 inches.

COMMENT: BOAT RAMP - The precast trapezoidal concrete slab (w/1 inch grooves ribs) originally installed outlasted the cast-in-place broom finished slab. Small stones in the boat ramp's surf zone have accelerated the erosion of the tremie concrete.

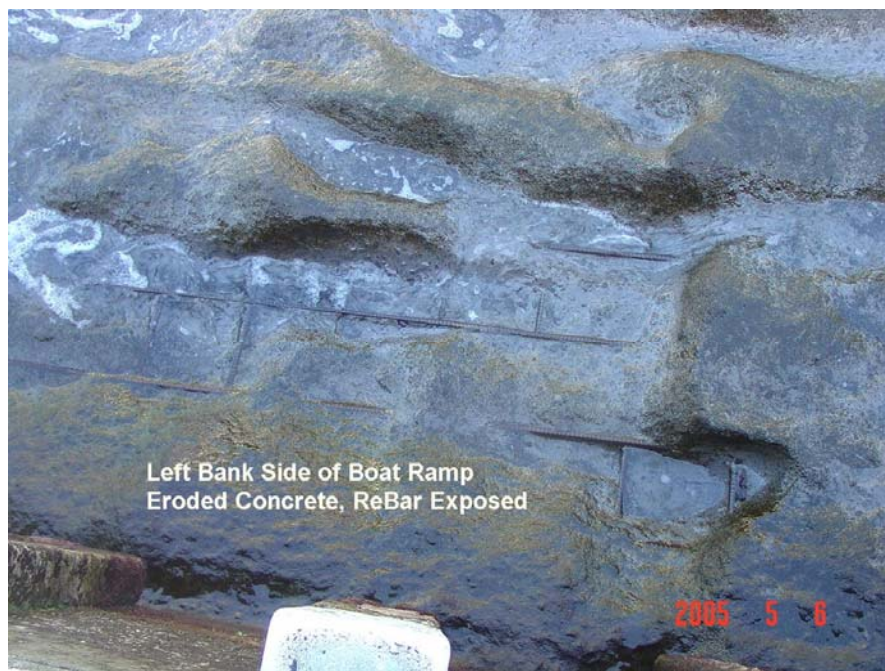
d. ReBar exposed, left side of poured-in-place slab.

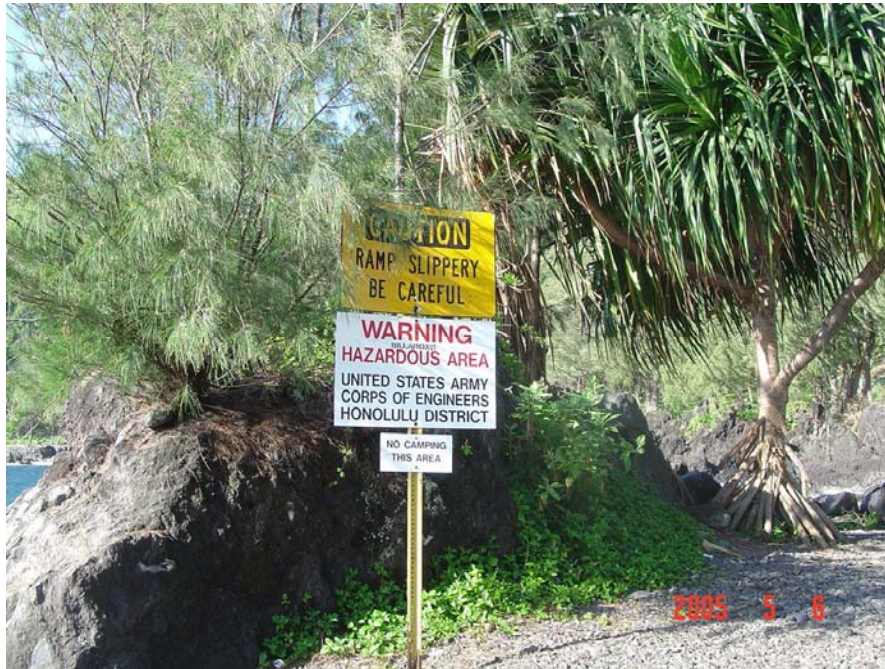
e. Remove unauthorized sign, not installed by COE and does not conform to Army Regulations.
